ASOS MODIFICATION NOTE 37 (for Electronics Technicians)

SUBJECT : Installing Visibility Firmware Version 037 and Visibility Crossarm Cable Guides

PURPOSE : To eliminate the heater diagnostic problem. Cable guides are added to restrain the cables from snagging and contacting the transmitter and receiver canisters.

EQUIPMENT AFFECTED: ASOS VISIBILITY SENSOR (AVIS)

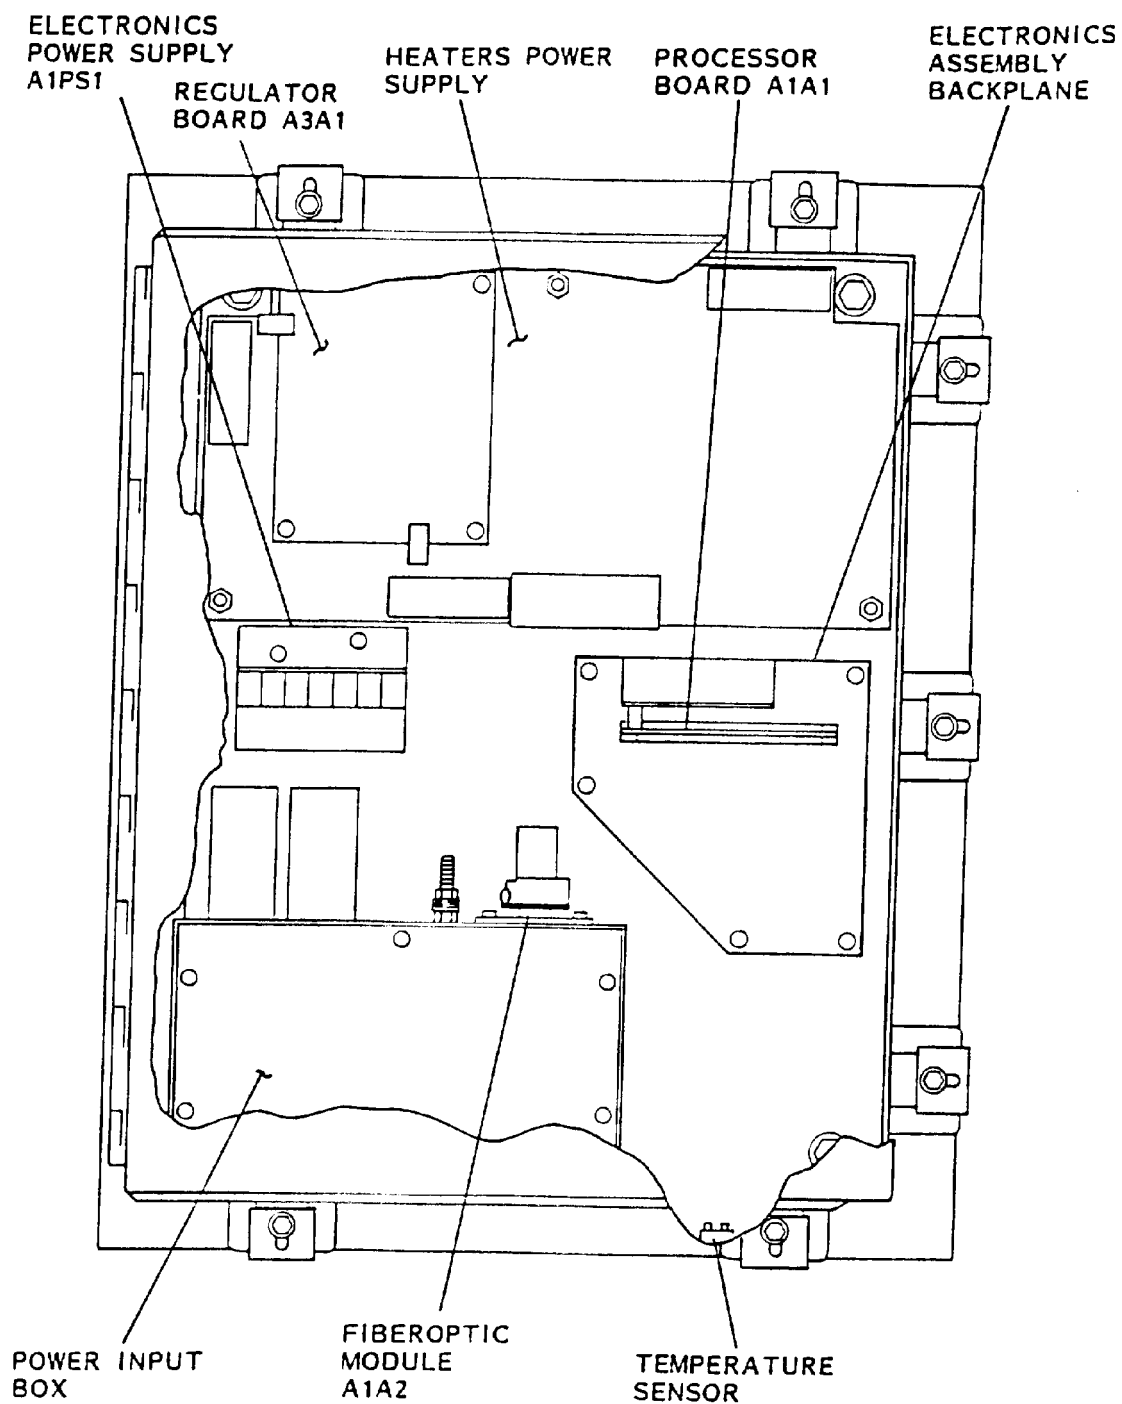
Figure 1 Visibility Sensor Electronics Enclosure

1. At the DCP cabinet, set the visibility sensor circuit breaker module to OFF (right) position.
2. At the sensor, using the large flat-tipped screwdriver, open the visibility sensor electronics enclosure access door and locate the processor board A1A1 (P/N 32194-1). Using the Phillips screwdriver, remove captive screw securing processor board to standoff. This screw is on the bottom side of the board. See figures 1 and 2.

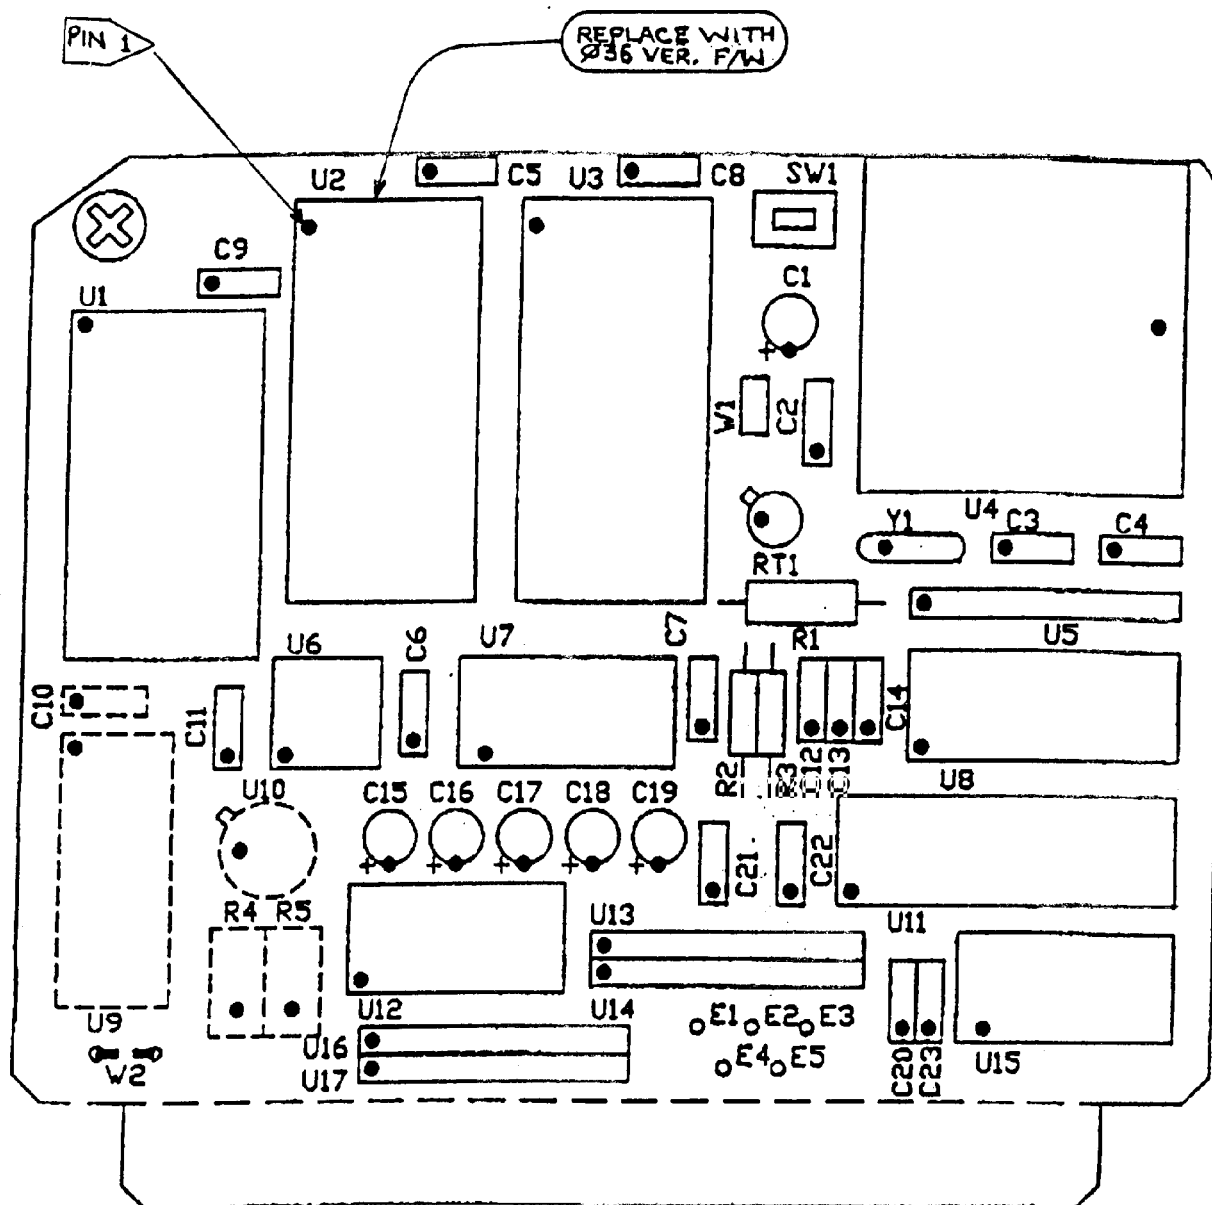
VISIBILITY PROCESSOR BOARD
P/N 32194-1
FIGURE 2

3. Carefully remove processor board by pulling it free from backplane connector XA1.
4. Using Figure 2, locate microcircuit U2. Remove the microcircuit using standard ESD precautions.

5. Install the supplied version 037 microcircuit, using care to match the index notch with the notch in the chip socket, assuring that pin 1 of the microcircuit matches pin 1 of the socket. Press firmly into socket.

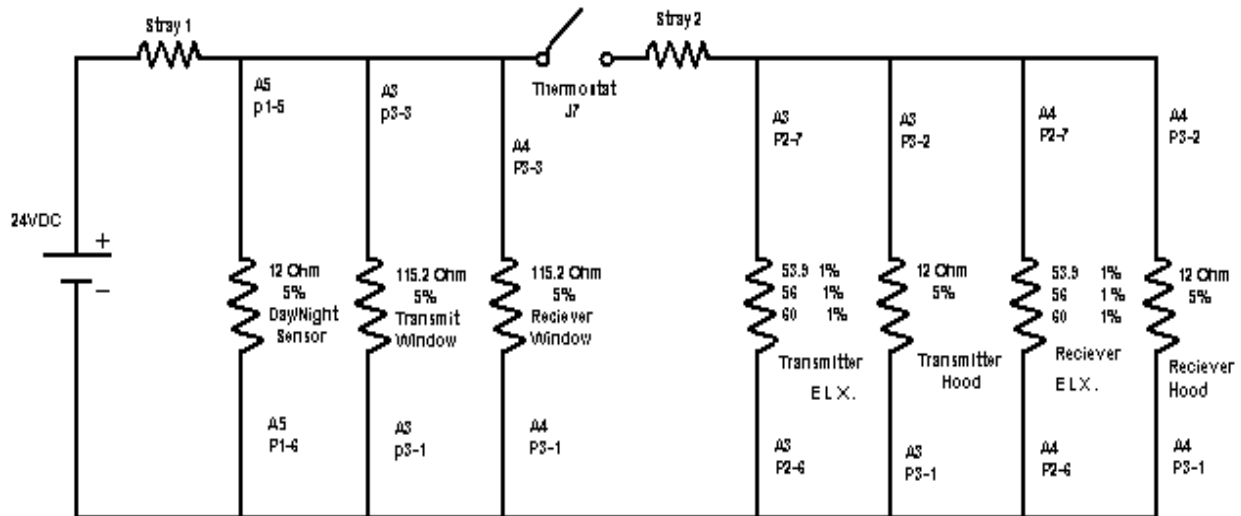
Heater Diagram
Figure 3

After following this procedure the sensor will no longer test individual sensor heaters during routine operation. Remember to place a note in the SYSLOG stating that heater diagnostics have been disabled in the Visibility Sensor. All Heaters must be checked with an Ohm meter every 90 days. Refer to the Heat Diagram (Figure 3). If Heaters fail, replace the appropriate FRU in accordance with the Site Technical Manual S-100.

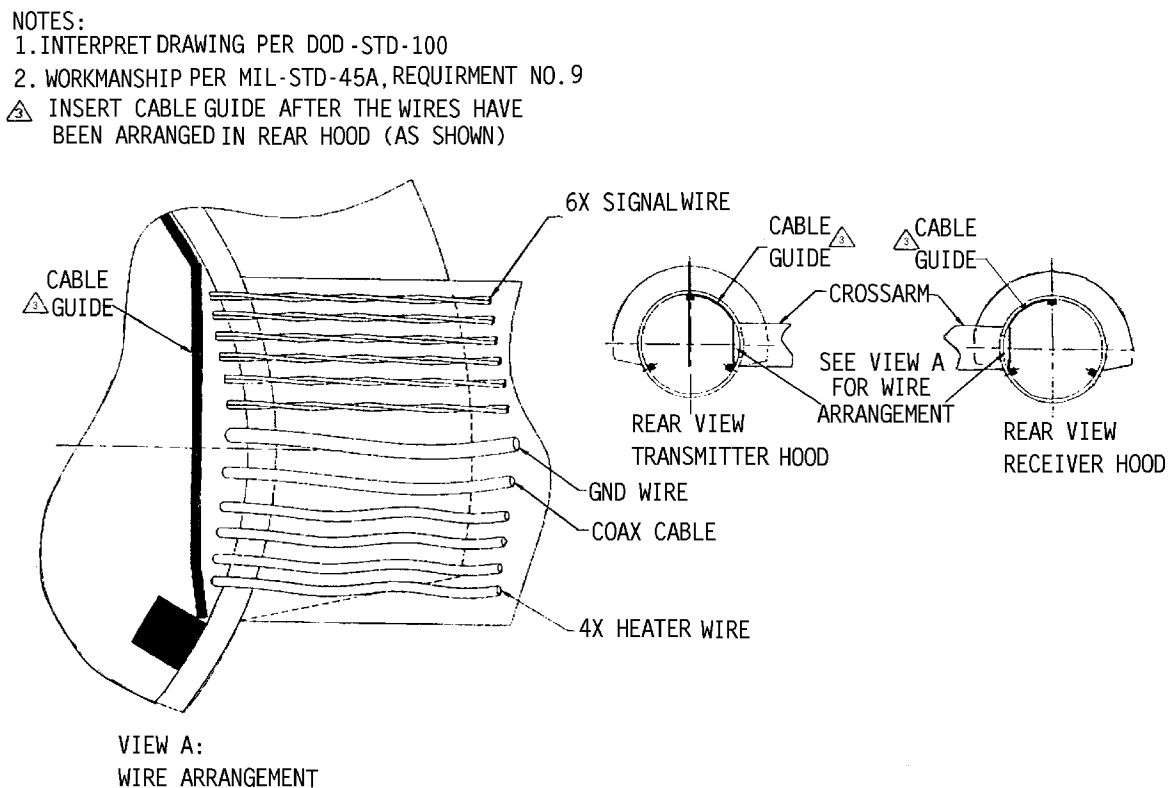
Figure 4

- b. With the tubing removed, the wire bundles can be flattened against the side of the hood. Arrange the wires so the larger heater wires, the green ground wire, and the coax cable are at the bottom as shown in the Figure 4.

- c. The cable guides are symmetrical, so they will fit in either hood. Holding the wires against the side of the hood, insert the guide so it is positioned between the upper and innermost of the canister slides. You will feel a positive indication that it is captured. Slowly press inward, keeping a slight pulling pressure on the wires to keep them from being snagged by the leading edge of the guide. Some wiggling might be required. The guide has been completely inserted when it bottoms-out against the window assembly.
